# KANGAROO LAKE

DOOR COUNTY, WISCONSIN

## COMPREHENSIVE LAKE MANAGEMENT PLAN

## Kangaroo Lake Association

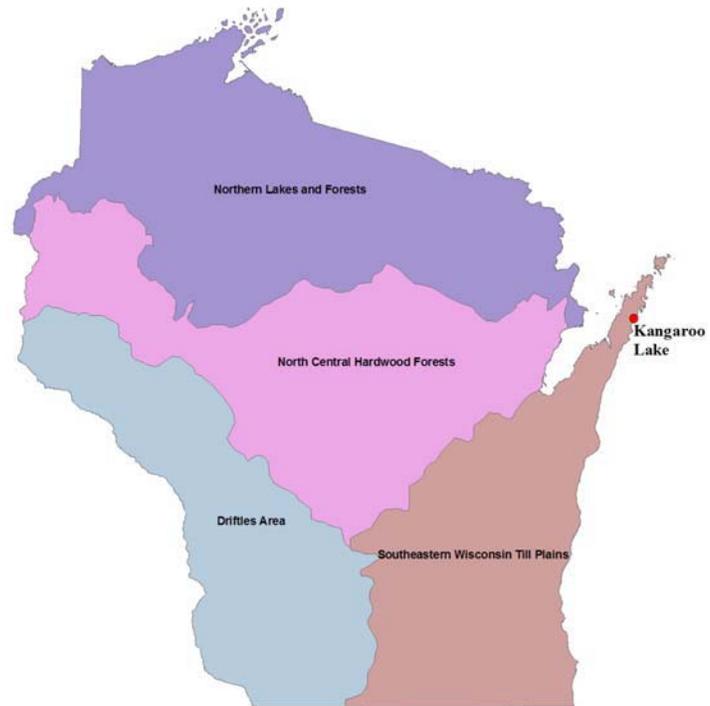
**Figure 7. Location of Kangaroo Lake relative to the ecoregions of Wisconsin after Nichols 1999 and Omernick and Gallant 1988.**

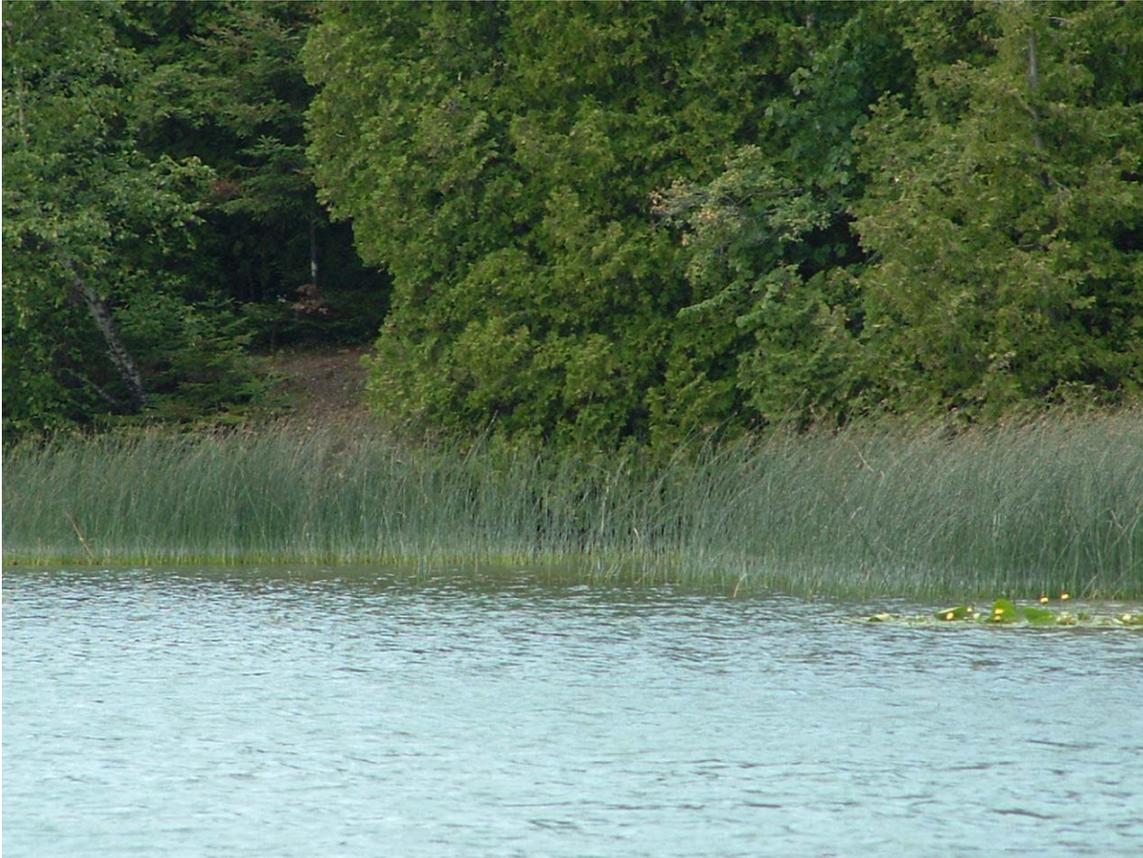
**Figure 2.** Sensitive Area 1

This site is located on the southern shore of the lake. It includes the entire area inside the buoys which is a slow-no-wake area out to approximately 5 feet deep which is about 700 feet from the shoreline out into open water.

The primary reasons for this site to be selected were the fishery values, wildlife values (and associated wetland habitat), water quality, and natural scenic beauty. This area has a diverse aquatic plant community that can provide important habitat for fish and wildlife. These plants provide important spawning, nursery, and cover area for fish and invertebrates. The aquatic vegetation provides excellent habitat for the production of macroinvertebrates (aquatic insects), which is an essential part of the food chain. The emergent bulrush stands are highly valuable in aquatic communities. The standing dead stalks are primary spawning habitat for northern pike and perch in the early spring. These species do not spawn on beds like bass and other panfish but spawn by broadcasting their eggs on standing material such as old stems, aquatic plants, or fallen timber. Without this material, spawning will not be successful. This same area could be a spawning site for smallmouth bass in late spring. Another benefit these plants have is due to the leaves having extensive spongy tissue and air space. This makes them great nesting material for

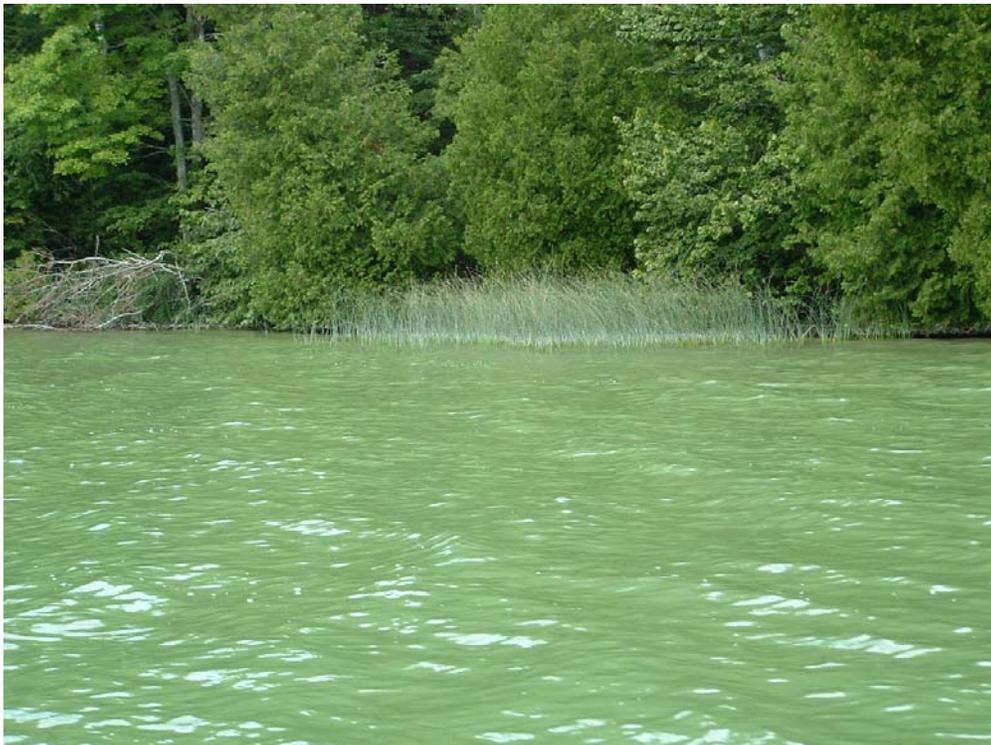
**Figure 3.** Sensitive Area 2

This site is located on the southwest shore starting at the access site owned by the Retreat going north along the shore for approximately 1400 feet. The site averages approximately 200 feet out into the water from shore. The site follows the contiguous undisturbed shoreline and consists of a variety of near-shore terrestrial and shoreline vegetation. This site is unique in that it is an undeveloped shoreline that is not adjacent to a wetland.

This site was selected because of the wildlife values, natural shoreland, and natural scenic beauty found at this location. A diverse, minimally disturbed near-shore terrestrial plant community provides for a variety of wildlife species. Birds, reptiles, and furbearers all use this site for shelter, nesting, and feeding areas. Wildlife will concentrate in this area as well due to the emergent rushes. The bulrushes provide food and cover for wildlife such as waterfowl and furbearers. Macroinvertebrates such as dragonflies and damselflies will use the emergent vegetation to crawl out of the water during metamorphosis (as they change to adults). Natural looking shorelands like this provide aesthetic value that is otherwise very limited.

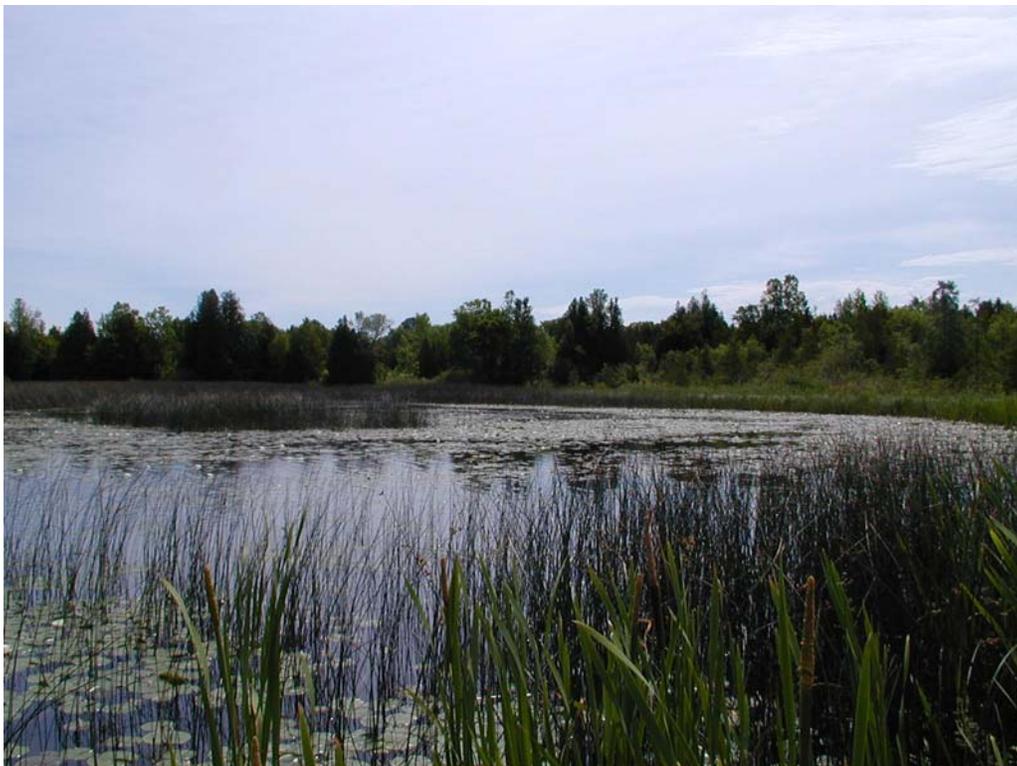
**Figure 4.** Sensitive Area 3

This site is on the northeast side of the lake. It consists of the entire bay area and follows the north shore approximately 250 feet. The shoreline in this area has little or no development.

The primary reasons for site selection include aquatic plant diversity, fishery values, wildlife values (and associated wetland habitat), and natural scenic beauty. The aquatic plants provide vital habitat for fish and wildlife. The vegetation provides important spawning areas for northern pike and largemouth bass. The site is used as a fish nursery and for feeding and cover for other fish and wildlife. Forage species such as minnows and suckers also utilize this area. The aquatic vegetation provides excellent habitat for the production of macroinvertebrates. Thousands of microscopic crustaceans can live on muskgrass (*Chara sp*) providing an important food source for young fish and waterfowl. The wetland complex provides excellent habitat for furbearers such as muskrat and mink. These species will take advantage of the proximity of the wetland to the lake as a place to rear young and feed. Taller trees along the fringe can be used by perching raptors such as Bald Eagle or Osprey. Both species depend on fish for food and their presence always seems to impress the people who utilize the lake. In addition to large birds, songbirds use this area for nesting and cover. Other lesser known species of salamanders depend on these types of wetlands to complete their life cycle. This minimally disturbed bay provides a peaceful oasis from the main lake. The large forested wetland adjacent to the lake provides for a natural setting on an otherwise developed lake.

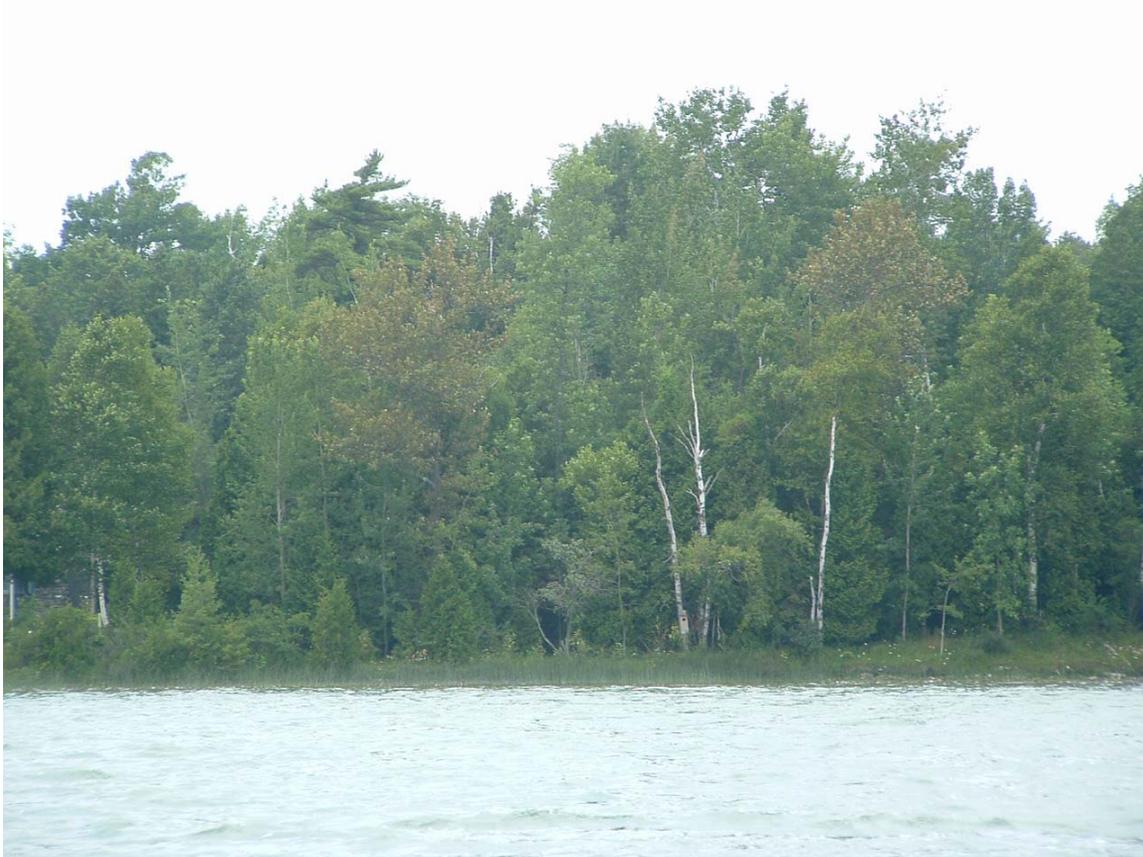
**Figure 5.** Sensitive Area 4

- Maintain and protect entire shoreland around the island
- Minimize disturbance and structures within the littoral zone
- Protect snag trees and large trees on the island

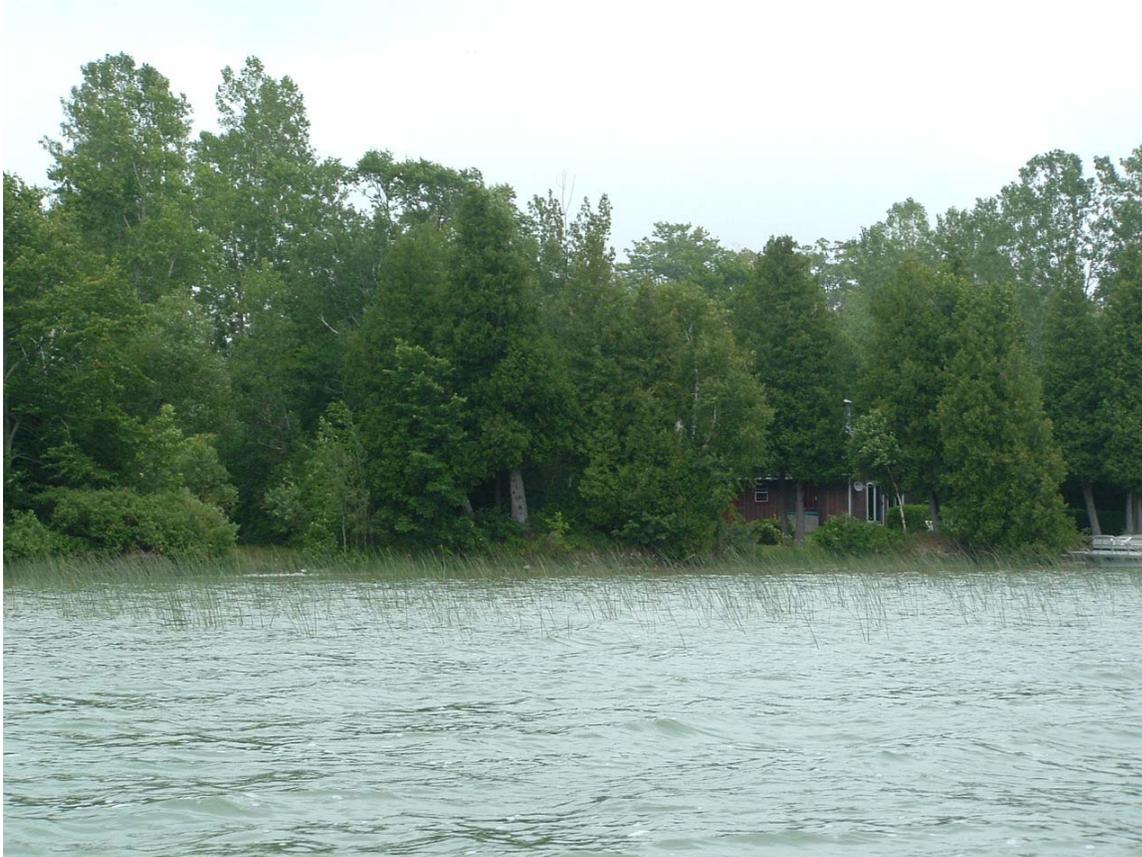
**Figure 6.** Sensitive Area 6

- Protect the adjacent wetland
- Do not remove native aquatic vegetation by physical, mechanical, or chemical means - especially the emergent species
