KANGAROO LAKE COMPREHENSIVE STUDY/MANAGEMENT PLAN

AQUATIC PLANTS AND THEIR CRITICAL ROLE IN KANGAROO LAKE

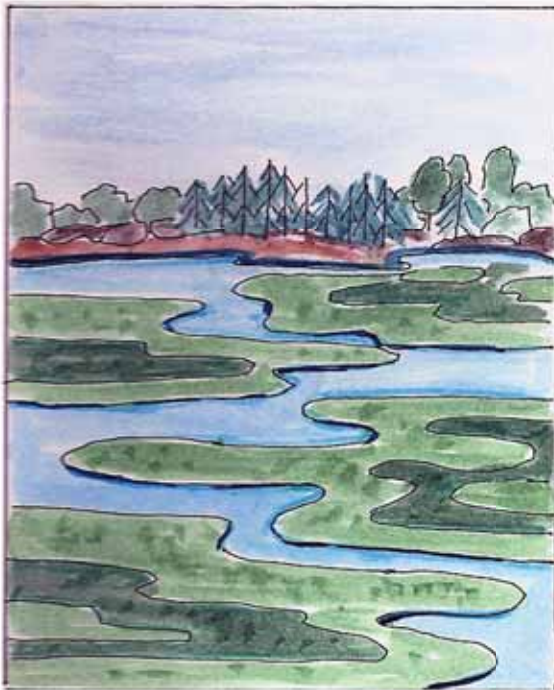
TURBID STATE

Because of competition for light, nutrients, and other needs, shallow lakes are normally dominated by either macrophytes (leafy plants, bulrushes) or algae. Lakes dominated by macrophytes are considered to be in a "clear state" (Kangaroo Lake's current state) and lakes dominated by algae are considered to be in a "turbid state" (Lake Winnebago is an excellent example).

Continued loss of aquatic macrophytes may cause Kangaroo Lake to shift to a "turbid state".
